MATERIALS FOR POTASSIUM LUBRICATED JOURNAL BEARINGS

Quarterly Progress Report No. 9
Quarter Ending July 22, 1965

prepared for
NATIONAL AERONAUTICS AND SPACE ADMINISTRATION
CONTRACT NAS 3-2534

SPACE POWER AND PROPULSION SECTION
MISSILE AND SPACE DIVISION
GENERAL   ELECTRIC
CINCINNATI, OHIO 45215

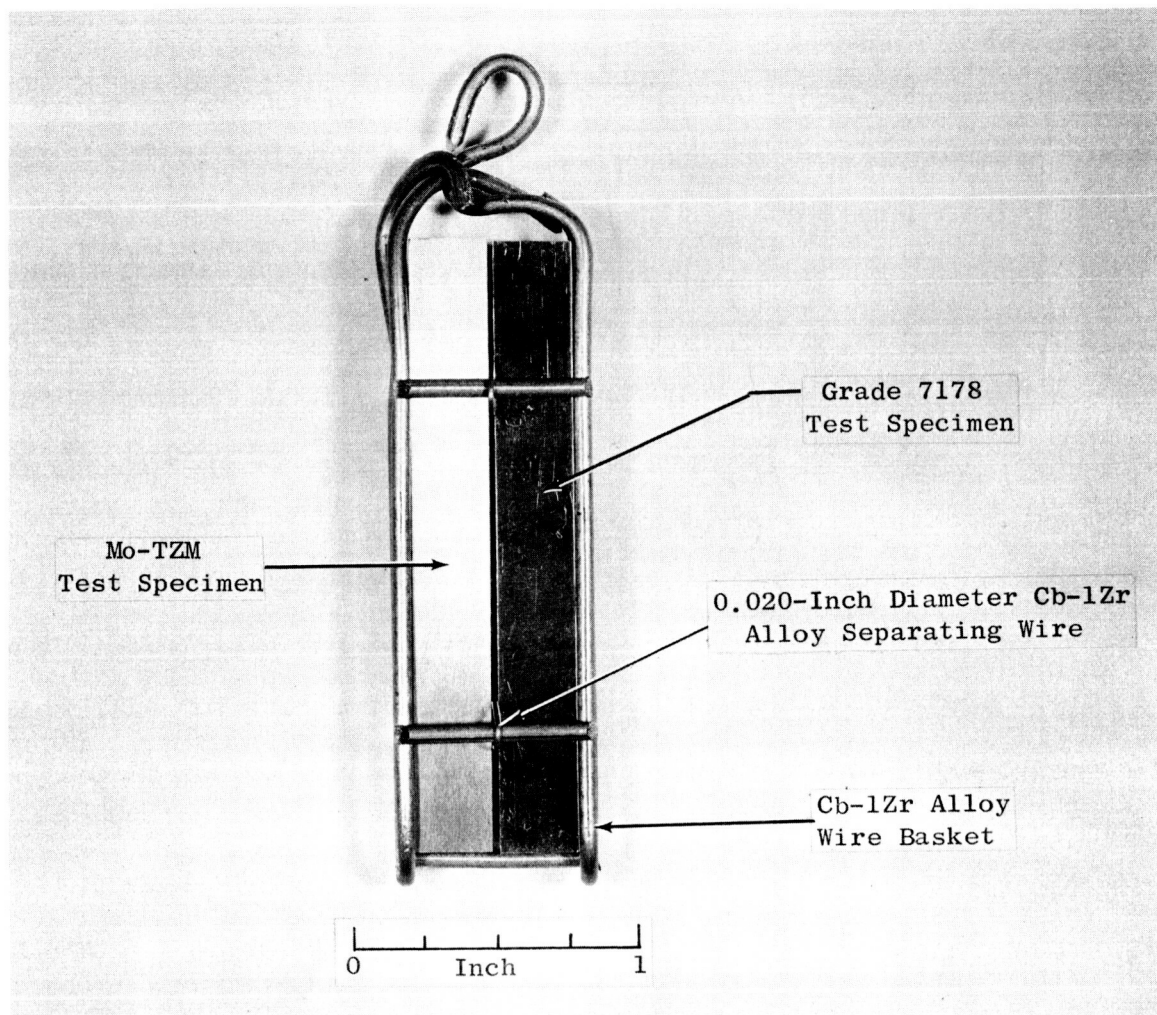
Figure 12. Mo-TZM Alloy and Grade 7178 Corrosion Test Specimens Prior to Being Inserted into a Cb-1Zr Alloy Capsule. The Cb-1Zr Alloy Wire Maintains Position and Spacing of the Specimens During the 1000-Hour Exposure to Potassium.

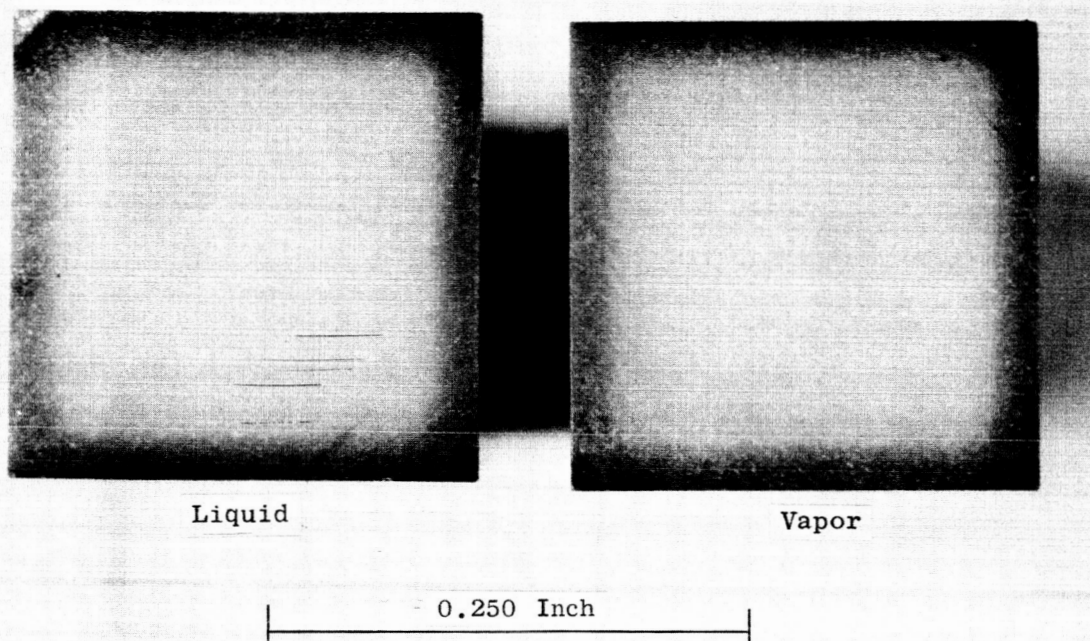
Figure 13. Sectioned Corrosion Specimens of Zircoa 1027 (95.5% ZrO_2) After Exposure to Potassium Liquid and Vapor for 1000 Hours at 800°F. (C65091240)

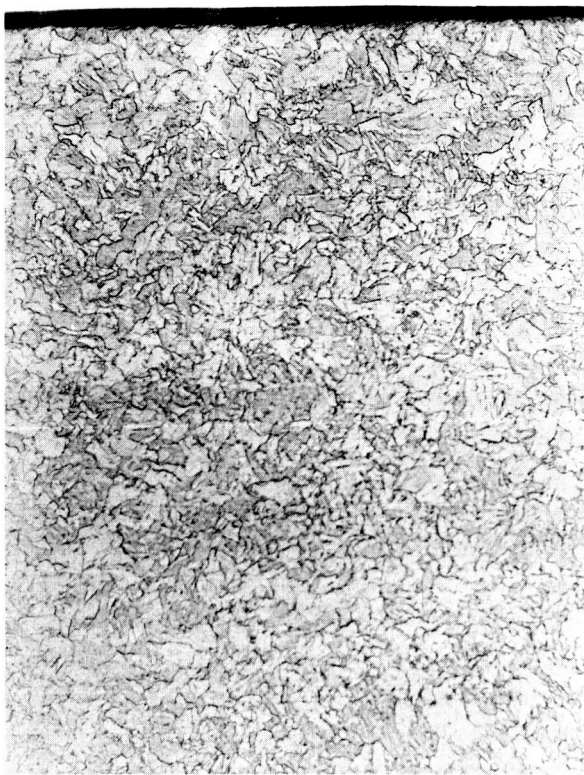
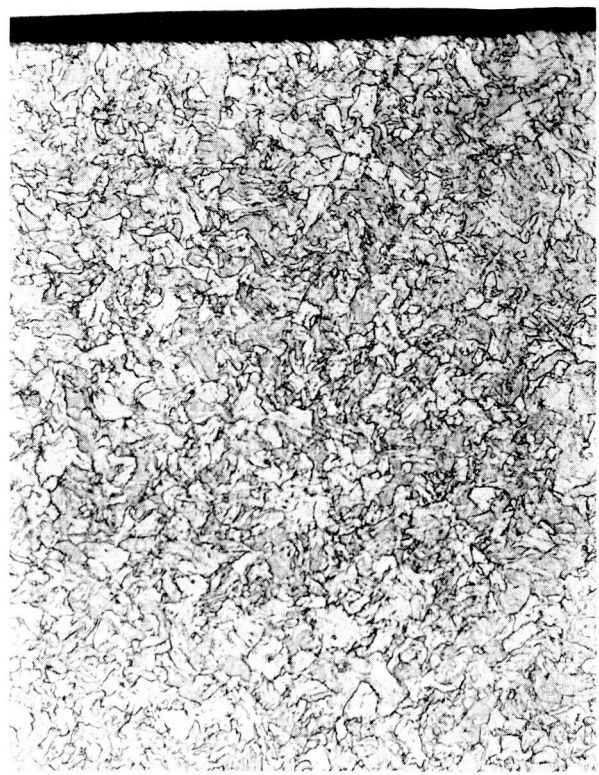
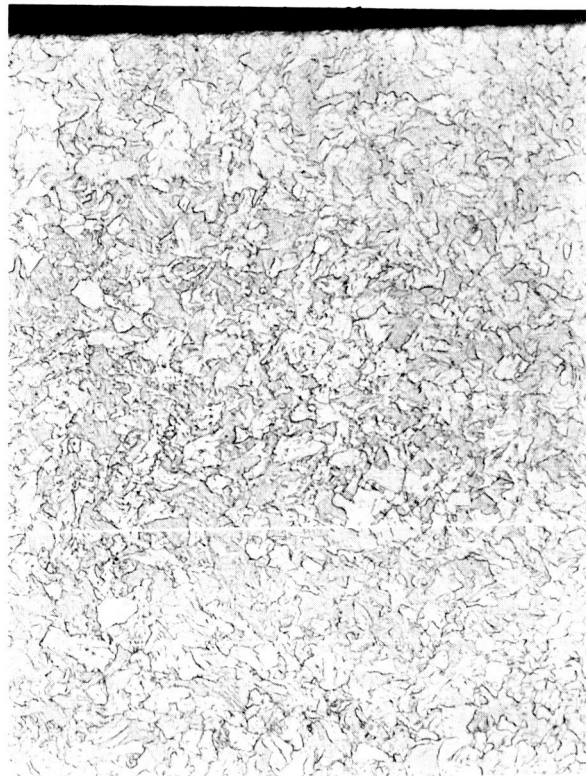
Post-Test Liquid Zone (A052121)

Post-Test Vapor Zone (A052221)

Pre-Test (A052111)

Figure 14. Microstructure of Transverse Section of Mo-TZM Alloy (Stress Relieved 2250°F 1/2 Hour) Before and After Exposure to Potassium Liquid and Vapor for 1000 Hours at 1600°F.
Etchant: 20% Murakamis

Metallographic examination of all specimens exposed individually to potassium for 1000 hours at 1600°F has been completed. No significant changes in microstructure were observed in any of the following materials as a result of the exposure to potassium liquid or vapor: Mo-TZM alloy, unalloyed tungsten, TiC+10%Mo, TiC+10%Cb, Lucalox (Al_2O_3) and TiB_2 ; slight surface attack to depths of 0.0002 to 0.0007 inch were observed in specimens of Carboloy 907, Carboloy 999, TiC and TiC+5%W; some surface roughening was apparent with the K601 specimens exposed to potassium liquid; and a general chemical reaction between Zircoa 1027 and potassium was observed changing the color of the specimens from light yellow to dark grey throughout the entire cross section. Although no corrosion reactions were evident for the Grade 7178 and Star J materials, morphological changes due to the thermal exposure were observed. Solution/aging reactions occurred in the Star J material and possible coalescence of the eutectic phase was observed in Grade 7178.

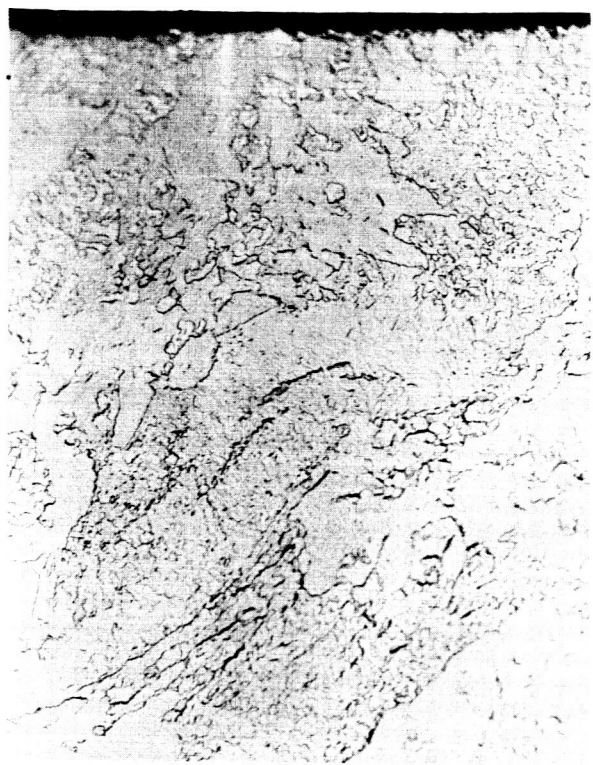
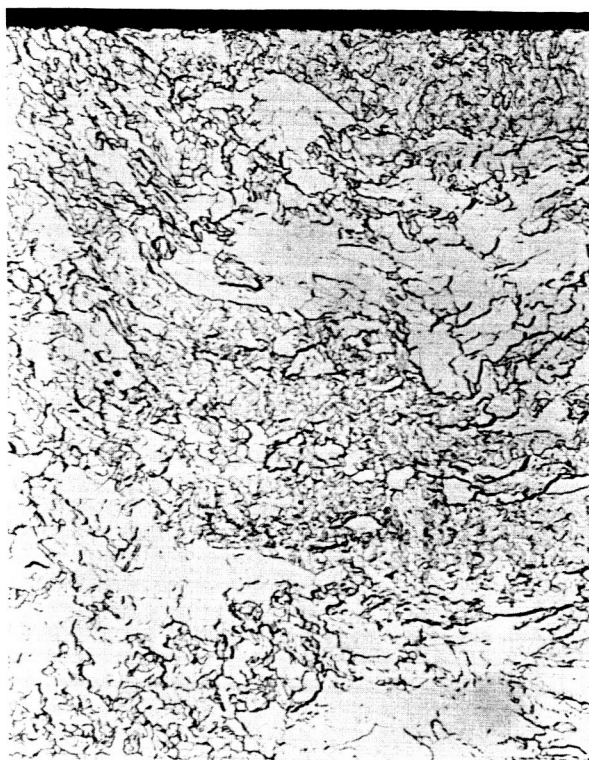
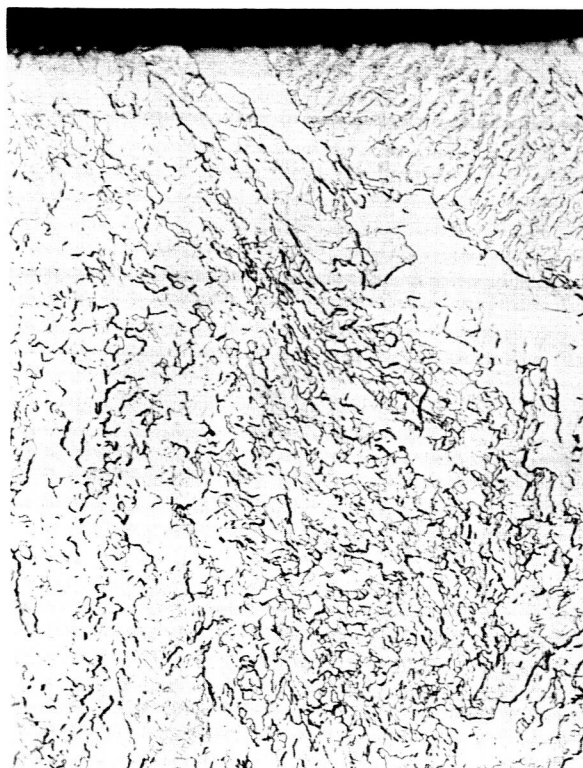
Post-Test Liquid Zone (A051321)

Post-Test Vapor Zone (A051421)

Pre-Test (A051311)

Figure 15. Microstructure of Transverse Section of Unalloyed Tungsten (Stress Relieved 2000°F One Hour) Before and After Exposure to Potassium Liquid and Vapor for 1000 Hours at 1600°F.
Etchant: 20% Murakamis Mag: 250X

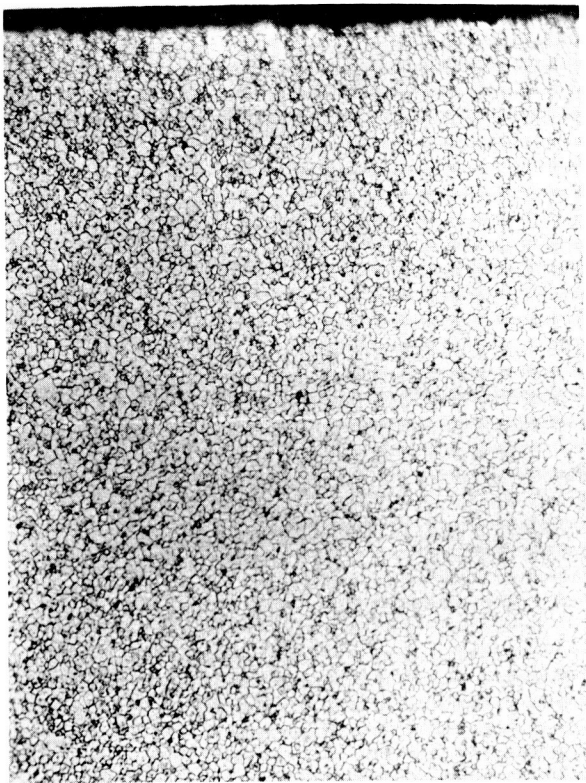
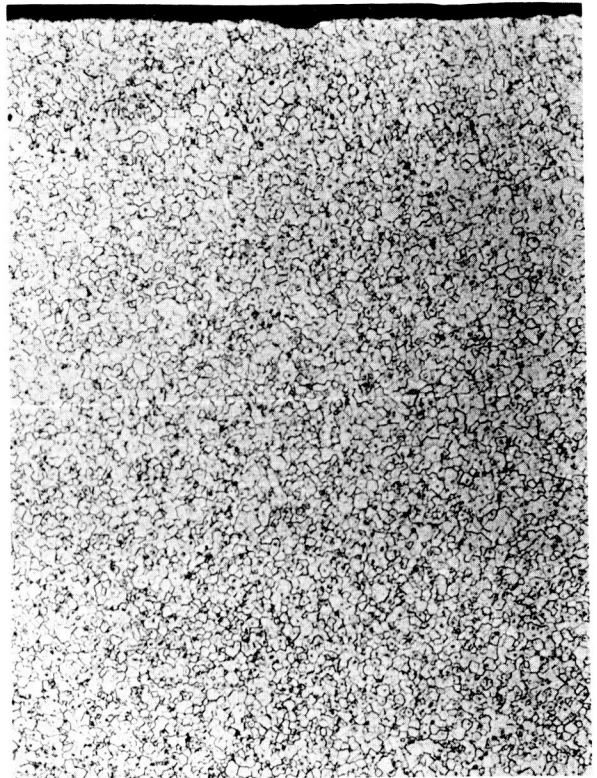
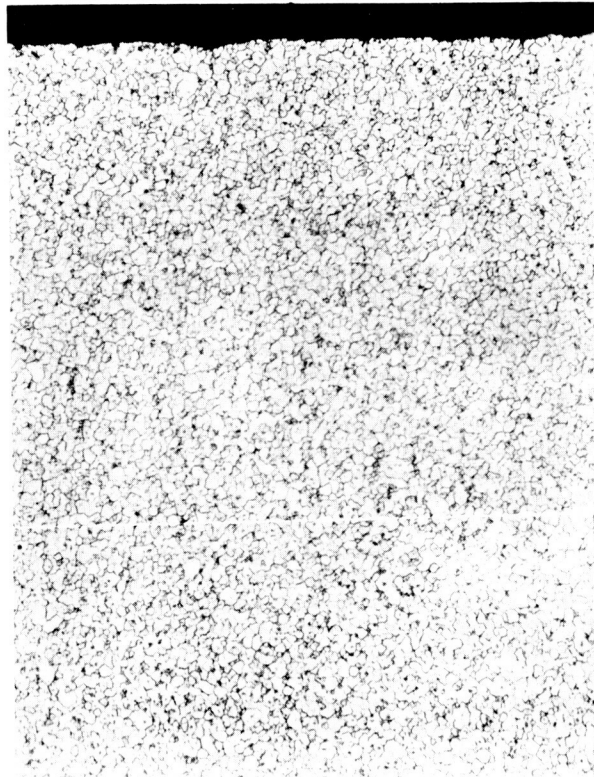
Figure 16. Microstructure of TiC+10%Mo Before and After Exposure to Potassium Liquid and Vapor for 1000 Hours at 1600°F.
Etchant: 80% HNO_3 +20% HF Mag: 250X

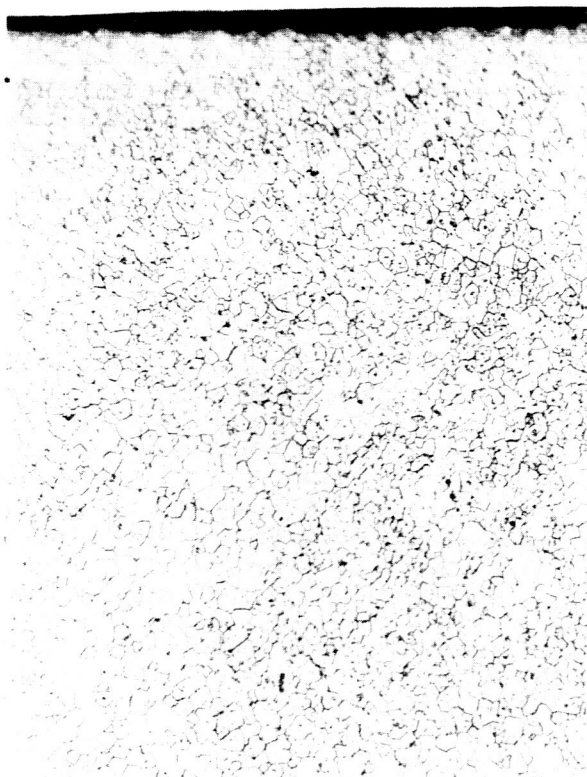
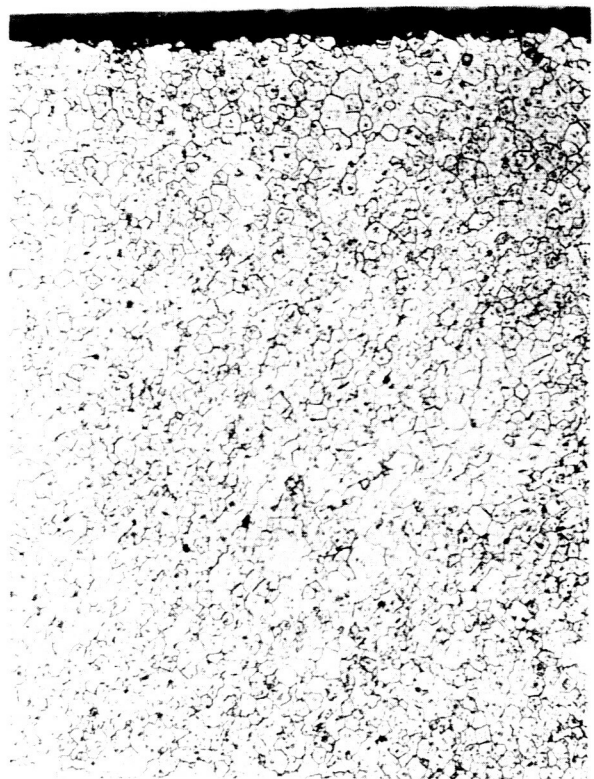
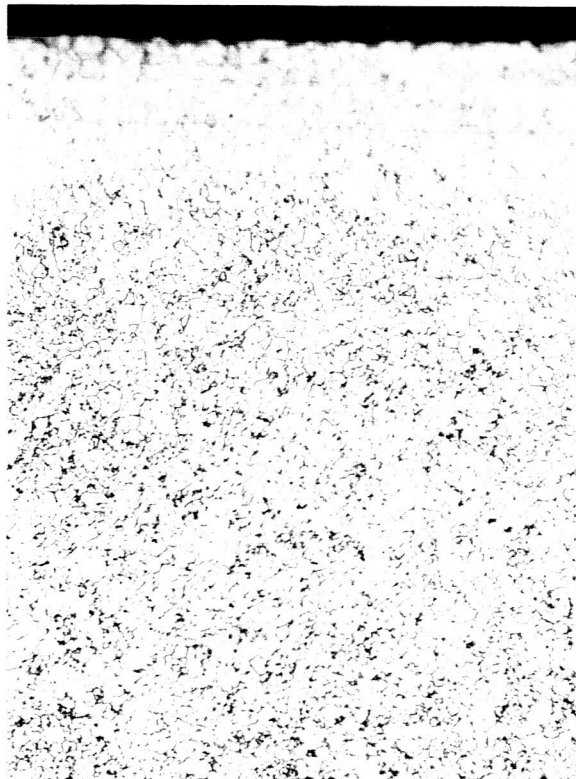
Figure 17. Microstructure of TiC+10%Cb Before and After Exposure to Potassium Liquid and Vapor for 1000 Hours at 1600°F.
Etchant: 80% HNO_3 +20% HF Mag: 250X

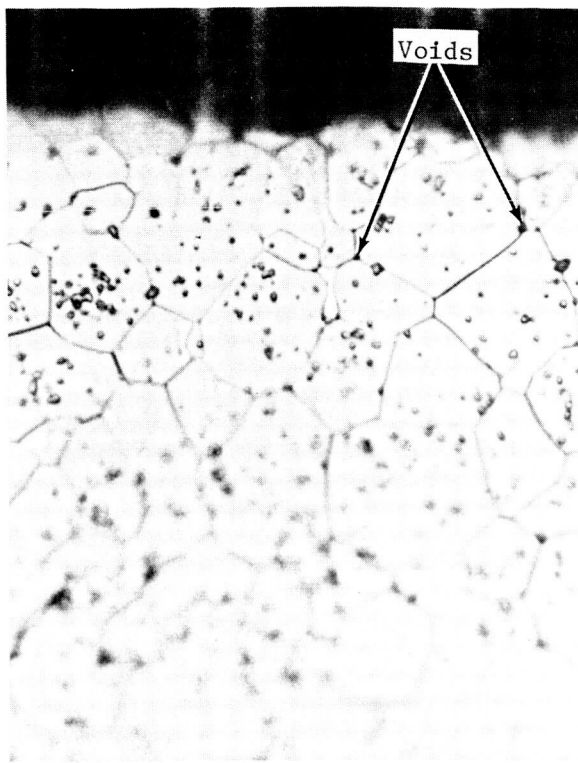
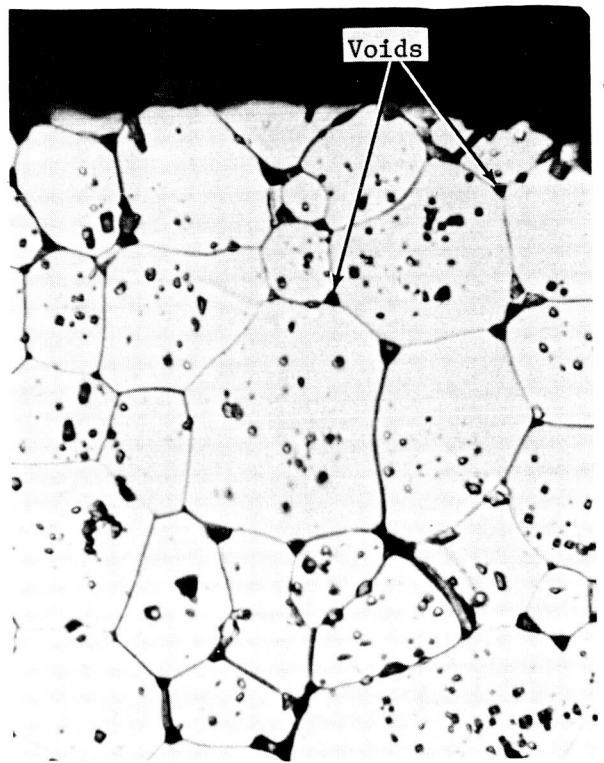
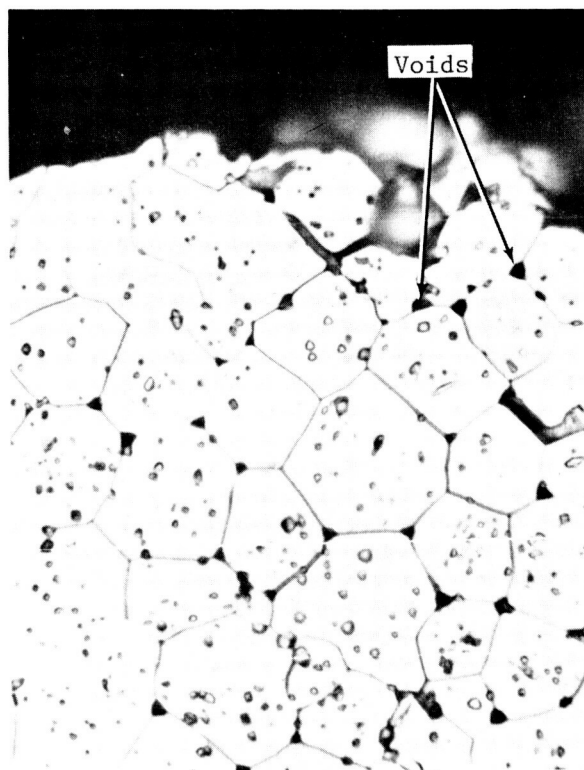
Figure 18. Microstructure of Tic+10%Cb Before and After Exposure to Potassium Liquid and Vapor for 100 Hours at 1600°F.
Etchant: 80% HNO_3 +20% HF Mag: 2000X

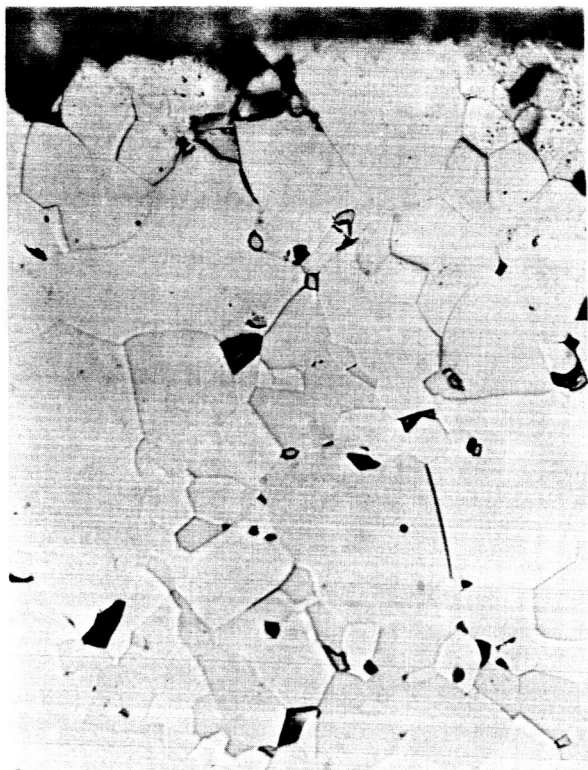
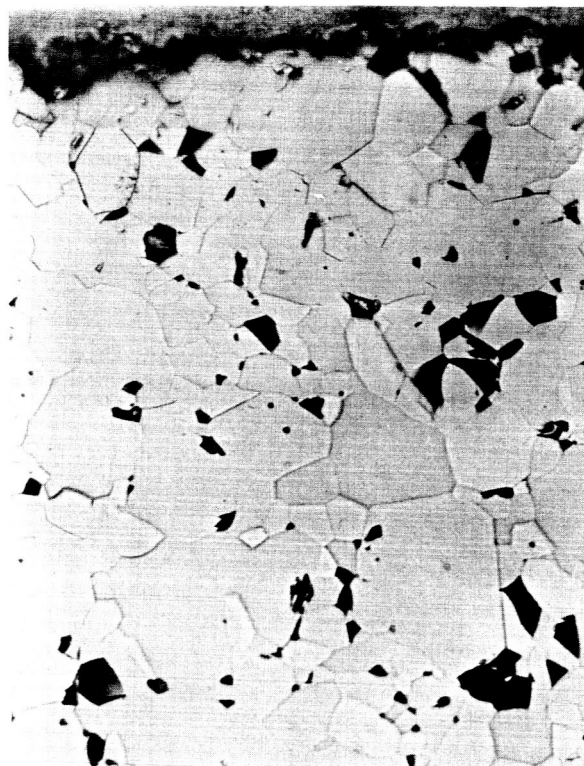
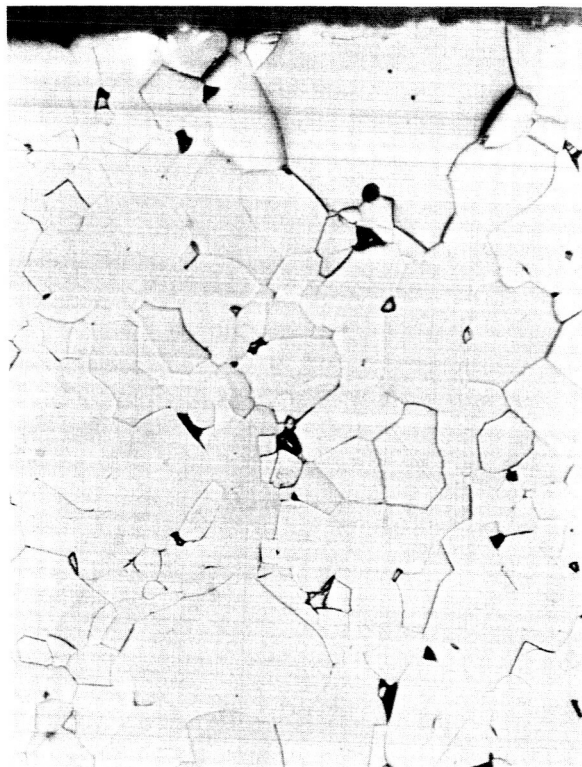
Figure 19. Microstructure of Lucalox (99.8% Al_2O_3) Before and After Exposure to Potassium Liquid and Vapor for 1000 Hours at 1600°F. Note: Apparent Porosity is a Combination of Pull Out During Polishing and Some Voids Enhanced by Etching.
Etchant: Boiling KF_2

The dimensional growth observed in the Lucalox (Al₂O₃) specimens tested at 1600°F is attributed to a surface reaction and the possible formation of KAlO₂ as was observed in compatibility studies at Battelle Memorial Institute (8). Corresponding weight increases also were noted with the Lucalox specimens tested at 1600°F. No apparent surface reactions occurred between the Lucalox specimens and potassium in the 1200° and 800°F tests and negligible changes in dimensions and weight were observed for the Lucalox (Al₂O₃) specimens tested at these temperatures.

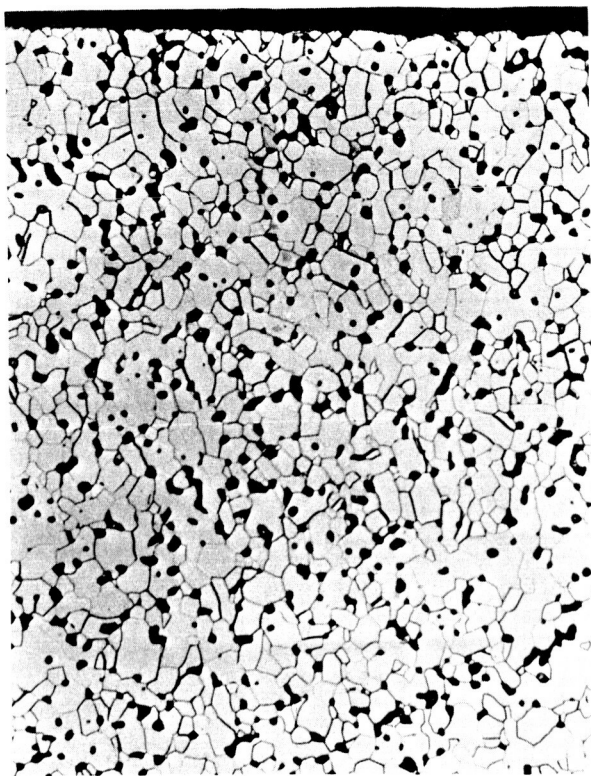
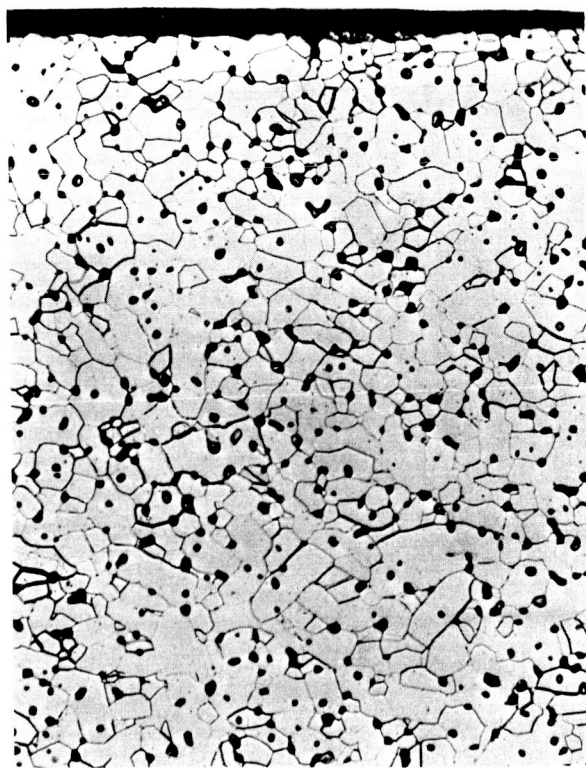
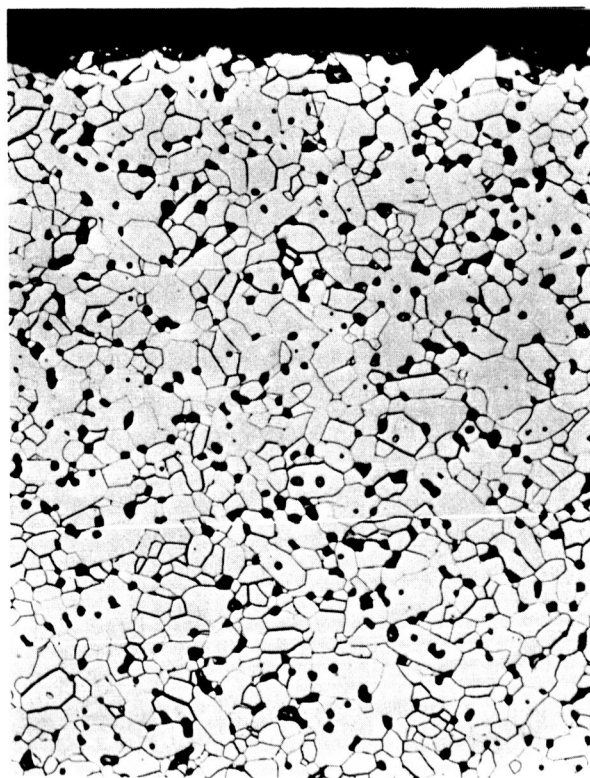
Figure 20. Microstructure of TiB_2 Before and After Exposure to Potassium Liquid and Vapor for 1000 Hours at 1600°F. Note: Apparent Porosity is a Combination of Pull Out During Polishing and Some Voids Enhanced by Etching.

A slight weight gain was observed in most of the TiB₂ specimens tested and is unexplainable at this time.

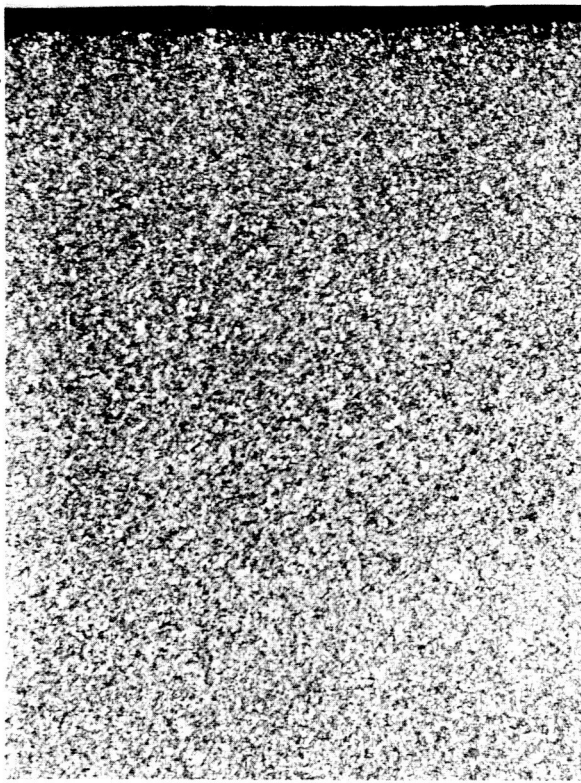
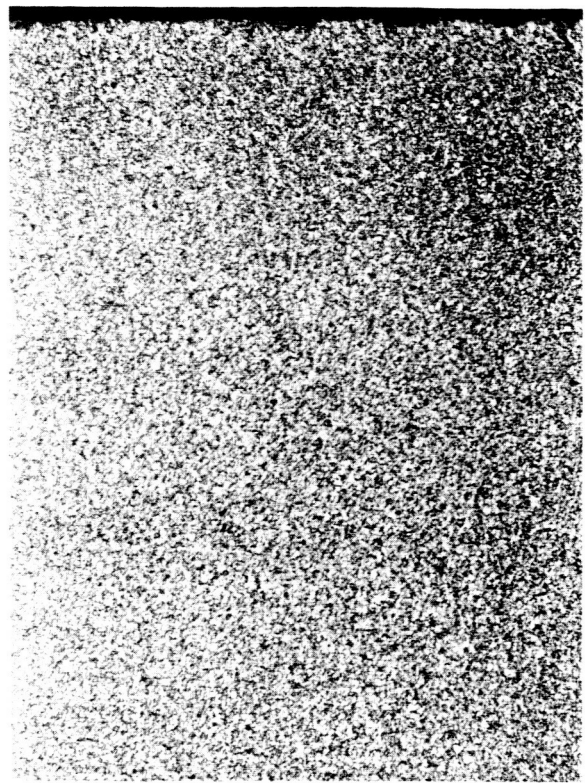
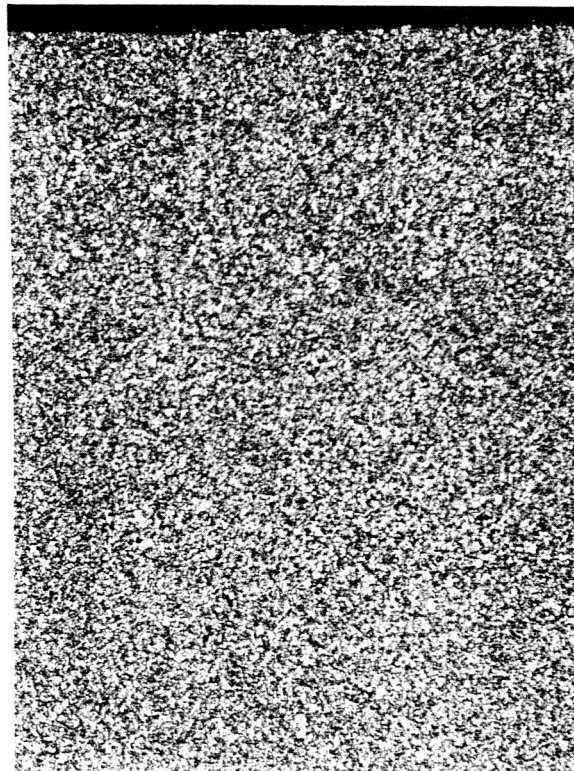
Figure 21. Microstructure of Carboloy 999 (97%WC-3%Co) Before and After Exposure to Potassium Liquid and Vapor for 1000 Hours at 1600°F.
Etchant: 10%NaOH, Electrolytic Mag: 250X

The weight losses of Carboloy 999 and Carboloy 907 specimens tested at 1600°F are attributed to the transfer of carbon from the specimens to the Cb-1Zr alloy capsule (2). Although the Carboloy specimens tested at 1200°F generally show a weight loss, the changes are significantly less than those observed for the specimens tested at 1600°F. Also, a slight dimensional growth was observed in the Carboloy 999 and Carboloy 907 specimens tested at 1200°F in contrast to negative changes in dimensions for the specimens tested at 1600°F. The positive dimensional changes of the Carboloy 907 specimen tested at 1600°F in liquid potassium is believed to be a surface reaction which resulted from an exposure to argon during the vacuum distillation cleaning after testing. The Carboloy specimens tested at 800°F show a slight dimensional growth and no negative weight changes.

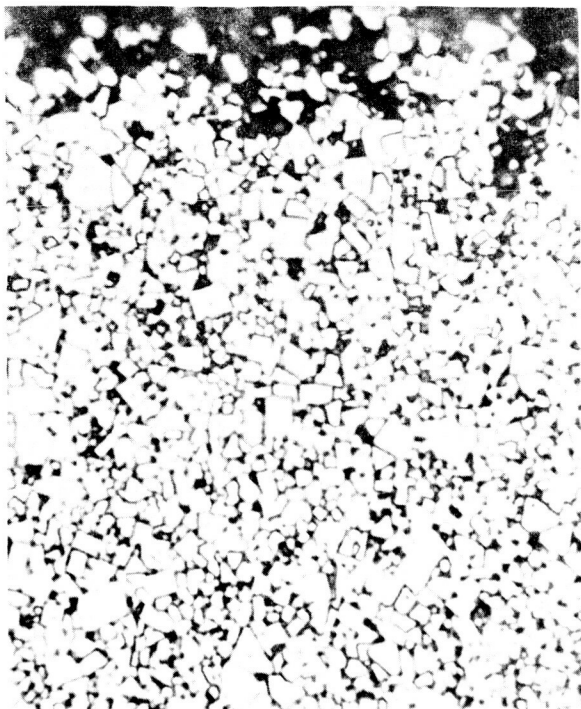
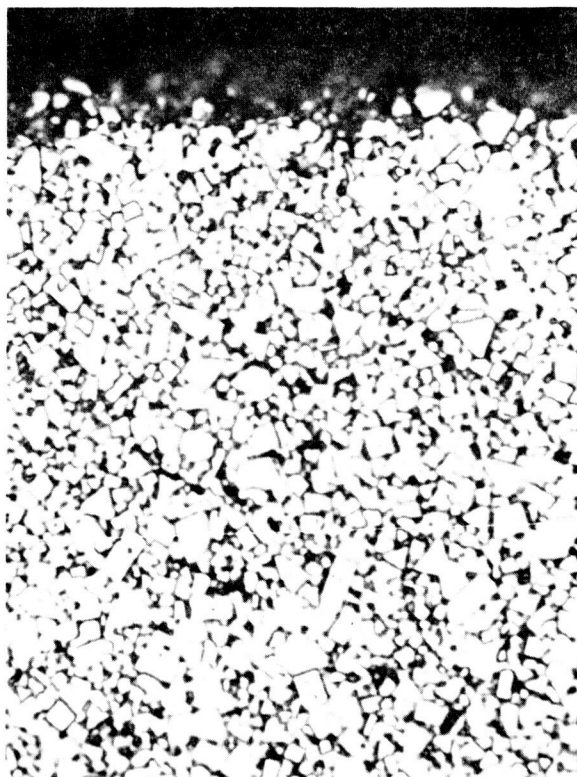
Post-Test Vapor Zone (A050423)
 Note Apparent Surface Attack
 to a Depth of 0.0004 Inch.

Post-Test Vapor Zone (A050423)
 Note Apparent Surface Roughening
 to a Depth of 0.0002 Inch.

Figure 22. Microstructure of Carboloy 999 (97%WC-3%Co) Before and After
 Exposure to Potassium Liquid and Vapor for 1000 Hours at 1600°F.
 Etchant: 10%NaOH, Electrolytic Mag: 2000X

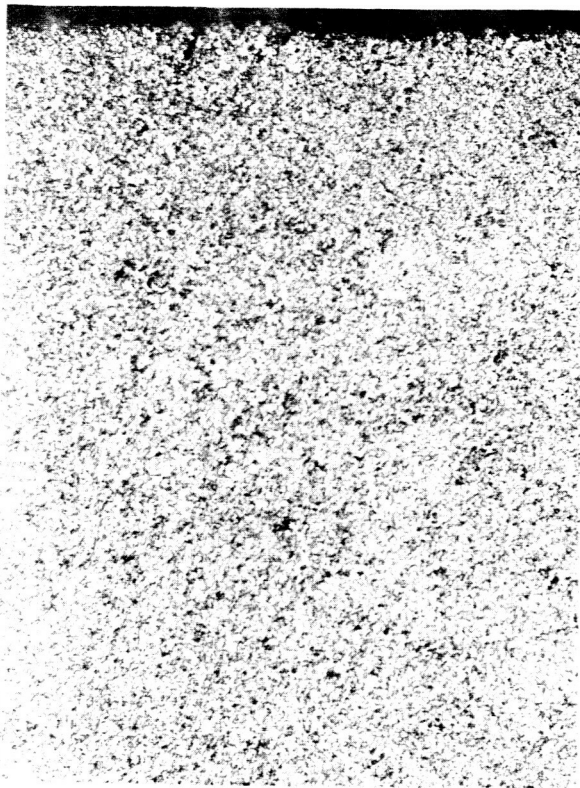
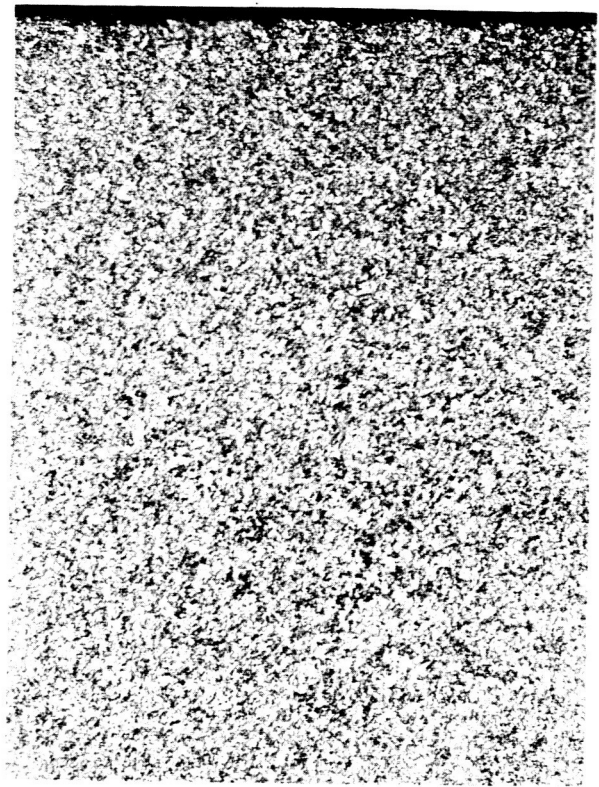
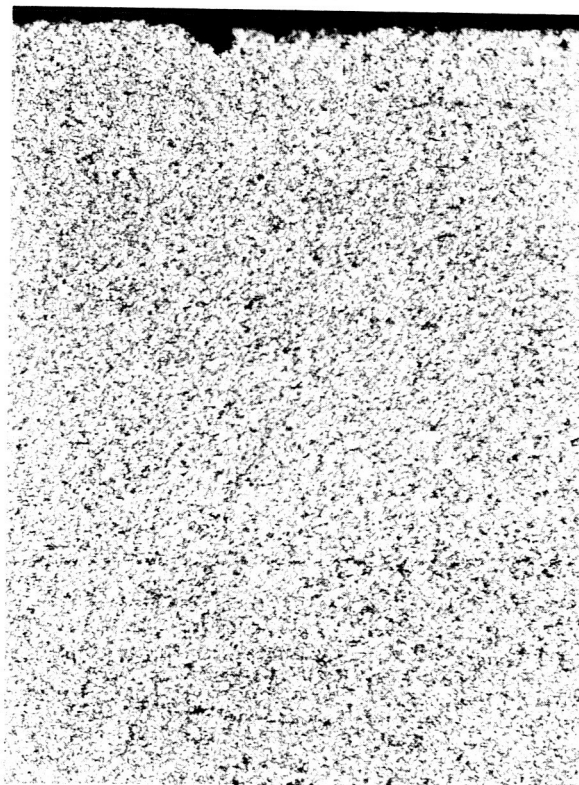
Figure 23. Microstructure of Carboloy 907 (74%WC-20%TaC-6%Co) Before and After Exposure to Potassium Liquid and Vapor for 1000 Hours at 1600°F.

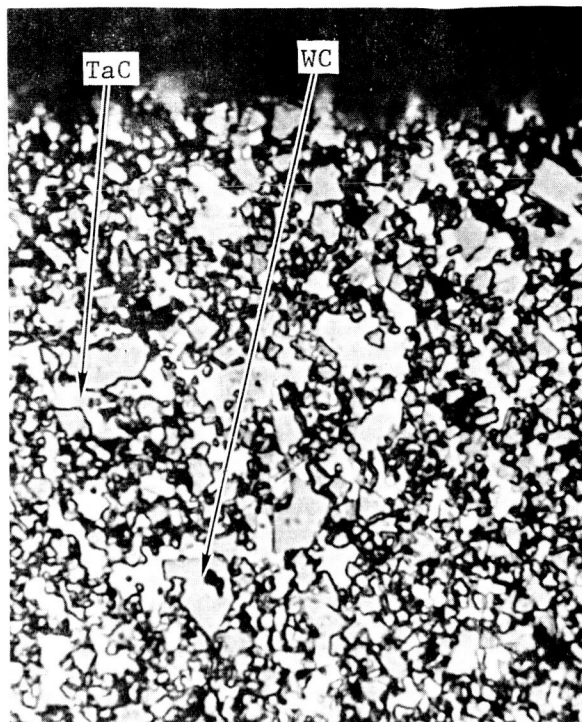
Post-Test Liquid Zone (A052323)
 Note Apparent Surface Attack
 to a Depth of 0.0007 Inch.

Post-Test Vapor Zone (A052423)
 Note Apparent Surface Roughening
 to a Depth of 0.0002 Inch.

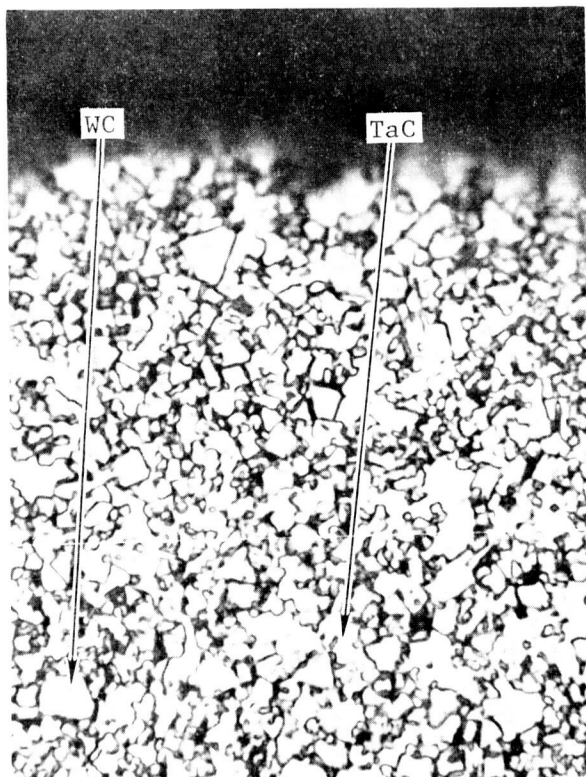
Figure 24. Microstructure of Carboloy 907 (74%WC-20%TaC-6%Co) Before and After Exposure to Potassium Liquid and Vapor for 1000 Hours at 1600°F.

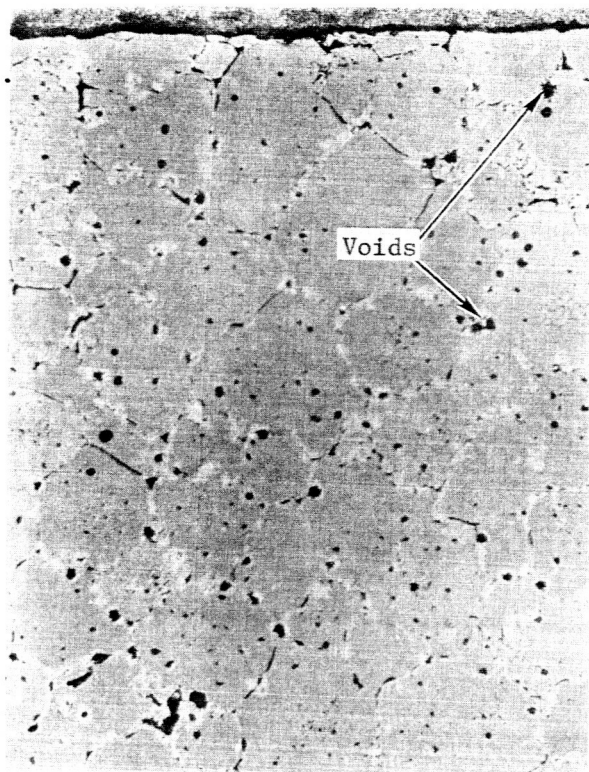
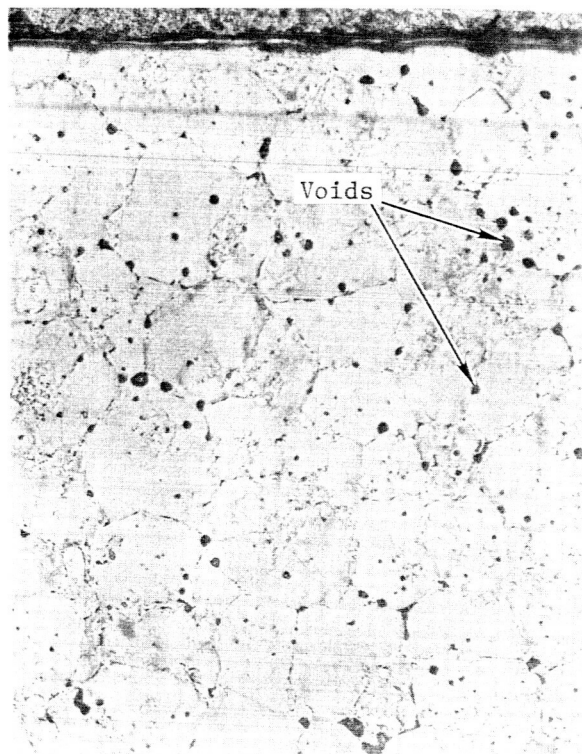
Figure 25. Microstructure of Zircoa 1027 (95.5ZrO_2) Before and After Exposure to Potassium Liquid and Vapor for 1000 Hours at 1600°F .
Etchant: Boiling $\text{H}_2\text{SO}_4 + \text{HF}$ Mag: 250X

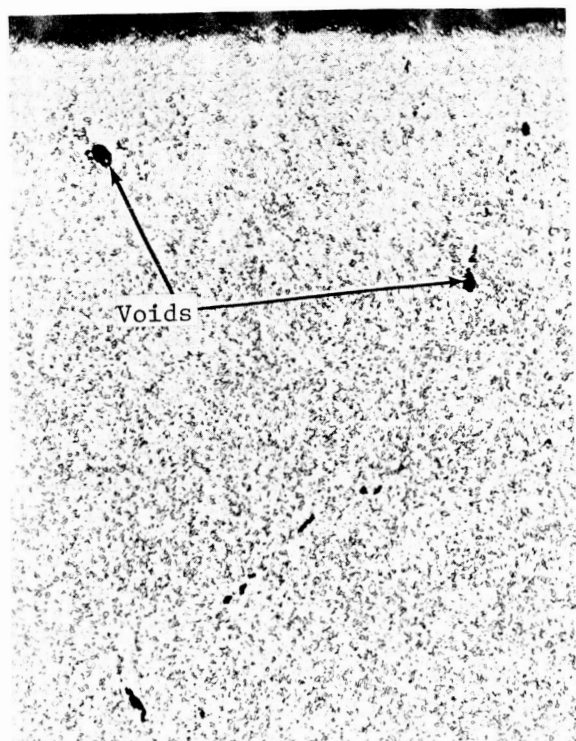
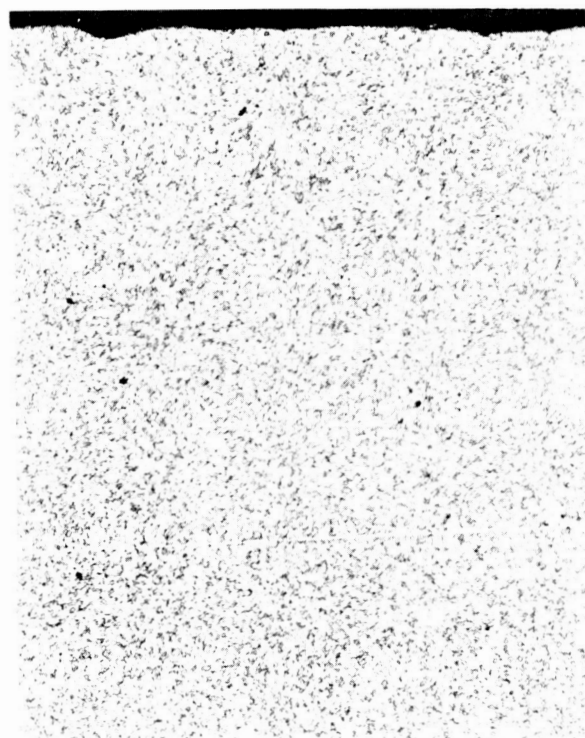
Figure 26. Microstructure of K601 (84.5%W-10%Ta-5.5%C) Before and After Exposure to Potassium Liquid and Vapor for 1000 Hours at 1600°F.
Etchant: 20% Murakamis Mag: 250X

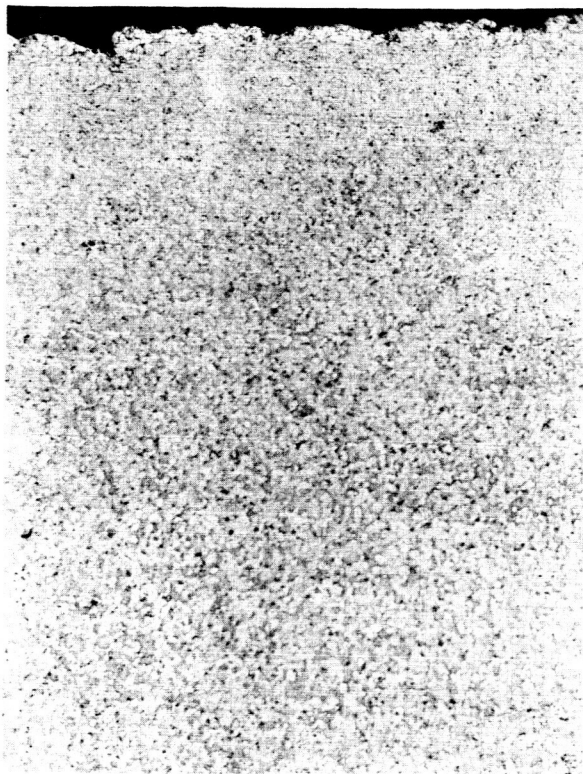
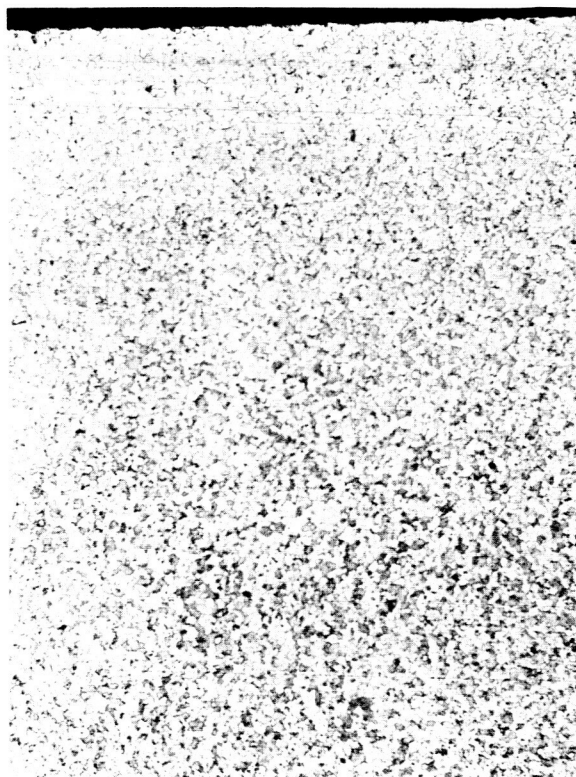
Figure 27. Microstructure of TiC Before and After Exposure to Potassium Liquid and Vapor for 1000 Hours at 1600°F.

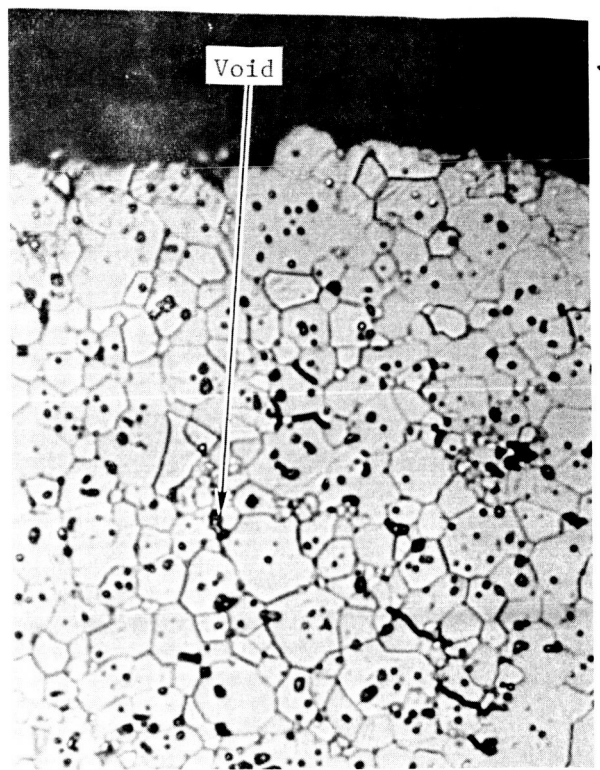
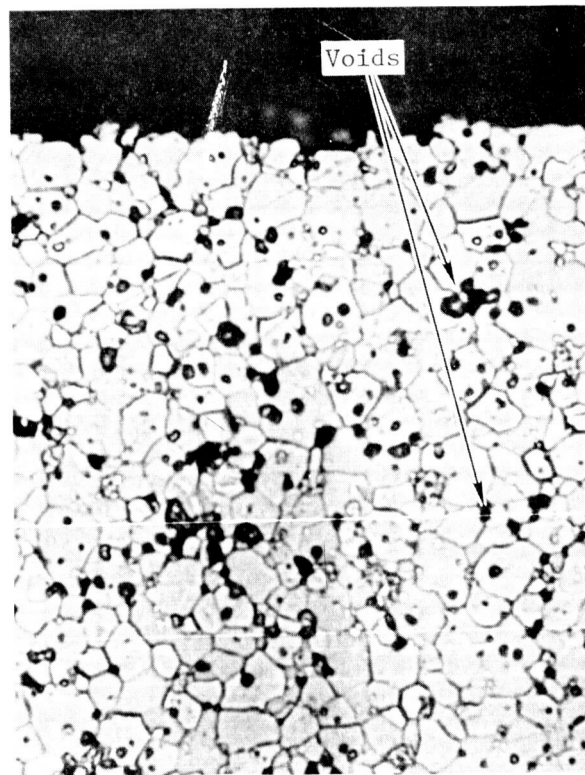
Figure 28. Microstructure of TiC Before and After Exposure to Potassium Liquid and Vapor for 1000 Hours at 1600°F.
Etchant: 80% HNO_3 +20% HF Mag: 2000X

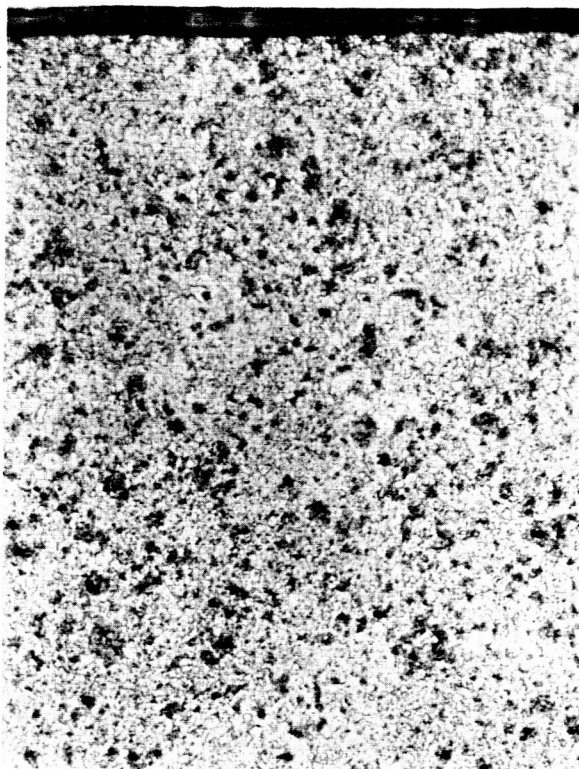
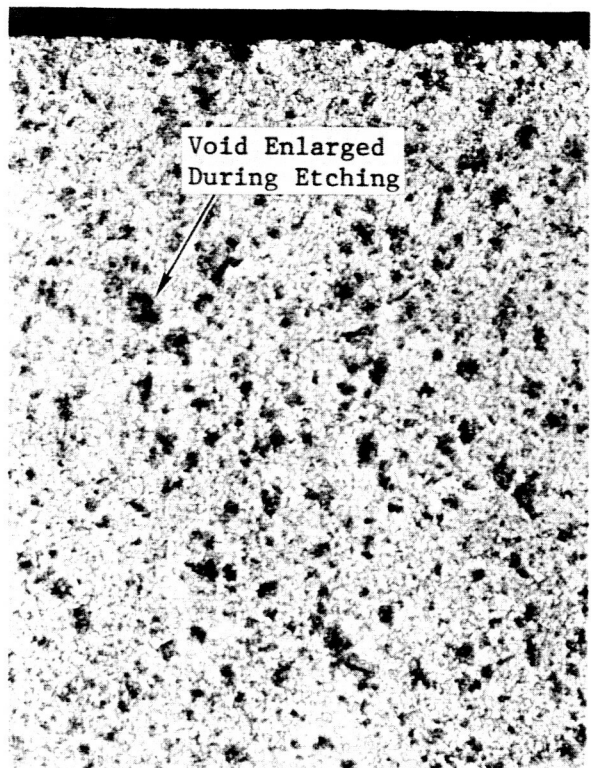
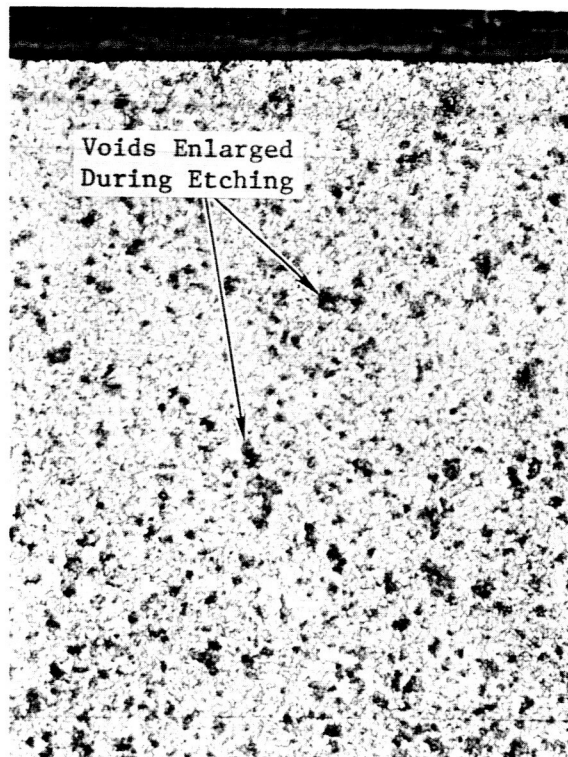
Figure 29. Microstructure of TiC+5%W Before and After Exposure to Potassium Liquid and Vapor for 1000 Hours at 1600°F.
Etchant: 80% HNO_3 +20%HF
